MARCH 2022
NEW YORK STATE DEPARTMENT OF STATE

MARITIME TECHNICAL WORKING GROUP ANCHOR STRIKE STUDY

SUMMARY REPORT

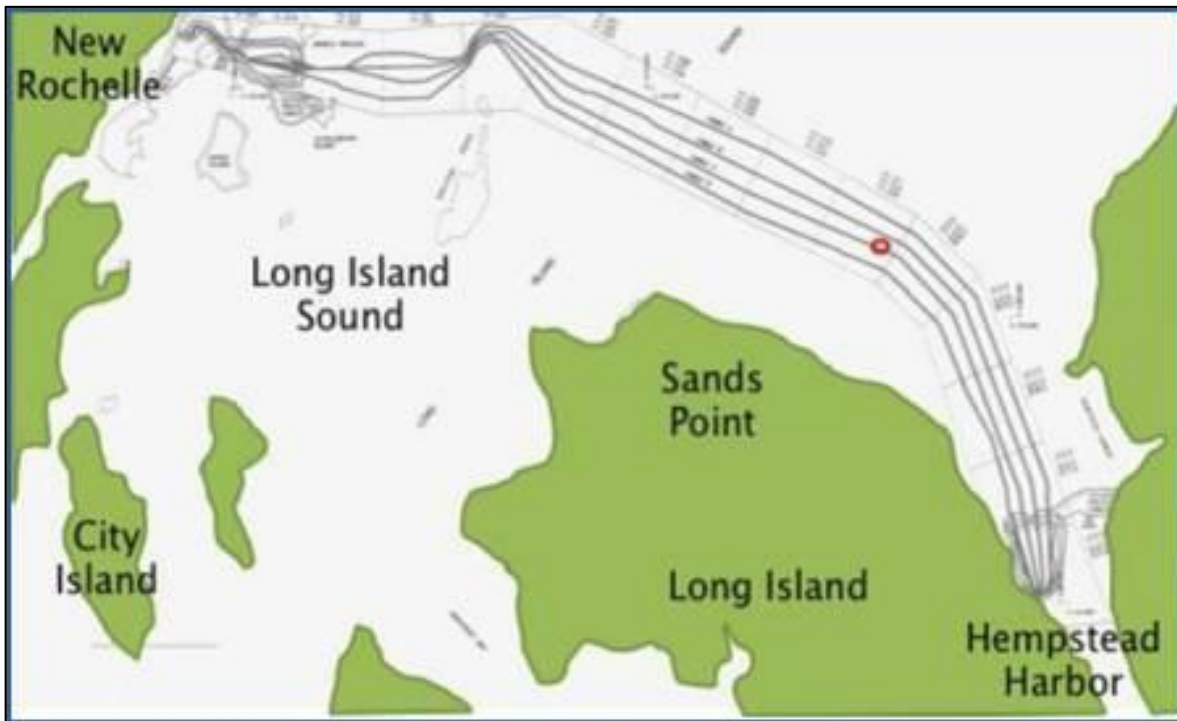
Figure 2-7 – Approximate location of damaged cable shown with red dot, Ref. [31]

On January 6, 2014 the motor tug *Ellen S. Bouchard*, operated by Bouchard Transportation Co., struck the C-phase Y-49 cable (one (1) of the four (4) cables) in the transmission line causing a fault. The incident occurred when the captain of the vessel misread a navigation chart and intentionally lowered the 6,000 lb anchor in the cable area of Hempstead Harbor. The exact location of the incident was not discovered by this study; however, an approximate location is shown in Figure 2-7. The anchor penetrated the seabed 10 ft and damaged the cable at an approximate water depth of 35 ft. Bouchard Transportation Co. sold the 1,000-ton DWT tug in bankruptcy proceedings in 2021. The cable was temporarily capped on January 28, 2014, but the leak was not fully stopped until February 27, 2014. It was estimated that dielectric fluid was leaking at a peak of 50 gallons per hour, for a total of approximately 66,000 gallons of fluid loss. Power was cut to all cables following the incident and electricity transmission was brought back to full operation by January 16, 2014 through the fourth spare cable. The damage was extensive and reportedly cost \$35M USD in repairs and clean-up. Permanent repairs required splicing a 200 ft long replacement section by means of a cable lay vessel.

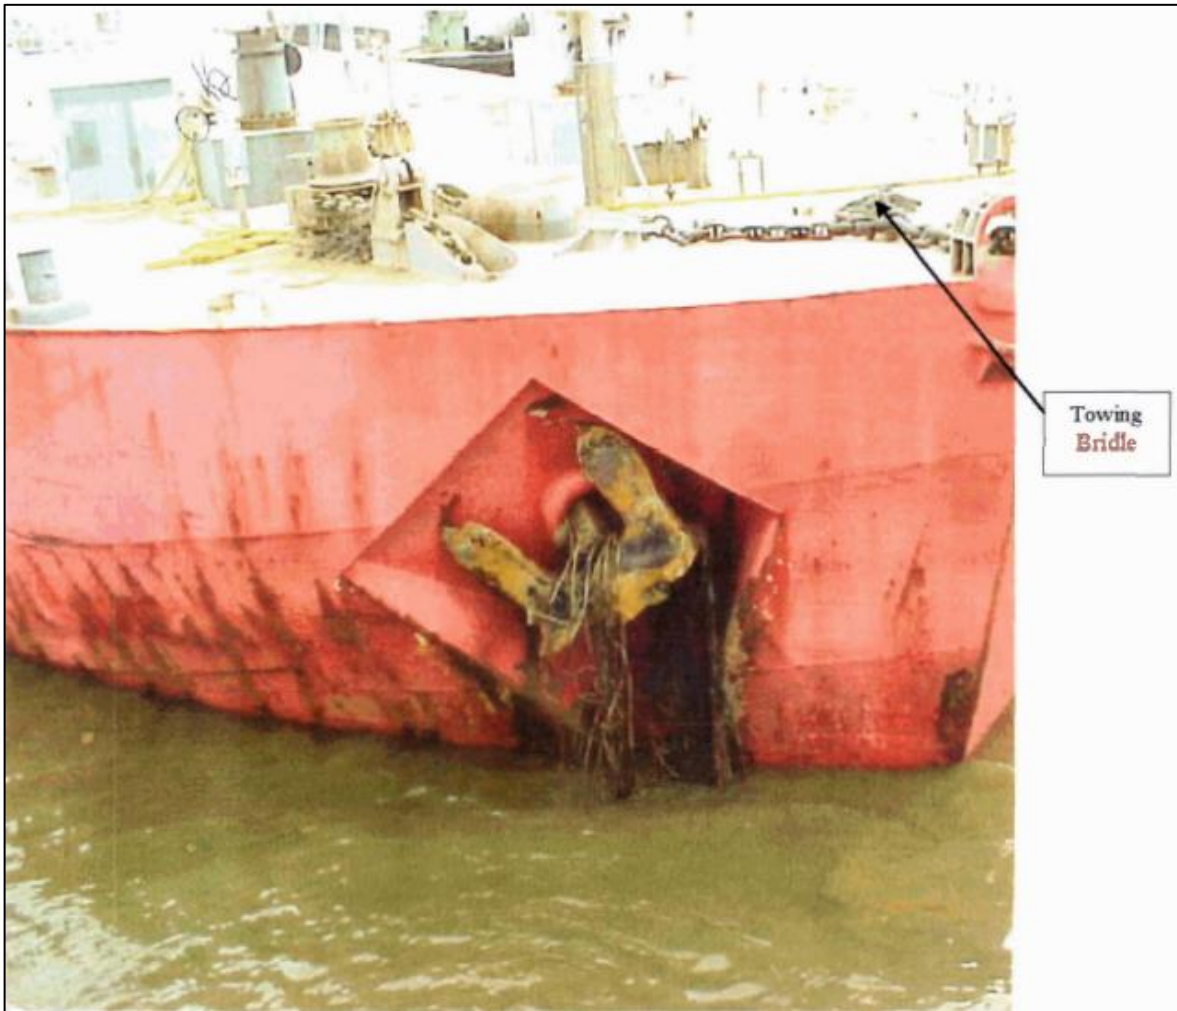
Figure 2-9 – *Maria T* cement barge anchor showing debris picked up from dragging anchor on riverbed, taken August 8, 1999, Ref. [33]

The *Maria T* has 8865 net tonnage and a 4500 lb fluke anchor with 7 shots (630 ft) of 2.25-inch anchor chain. The anchor that struck the PK pipeline was located on the starboard bow of the vessel. Figure 2-9 is a photo of the anchor directly following the event. Natural gas was released as a result of the damage, causing the water to bubble. Twenty-five people were evacuated from the area, and the waterway was closed for four hours as a precaution. Central Hudson Gas and Electric shut down flow of gas to the severed pipe following the incident. The prompt action of witnesses and Poughkeepsie Police to call the barge and request that they check the anchor prevented further damage to additional pipelines (4 inch and 8 inch) 15 miles down the river from where the *Maria T* was stopped.

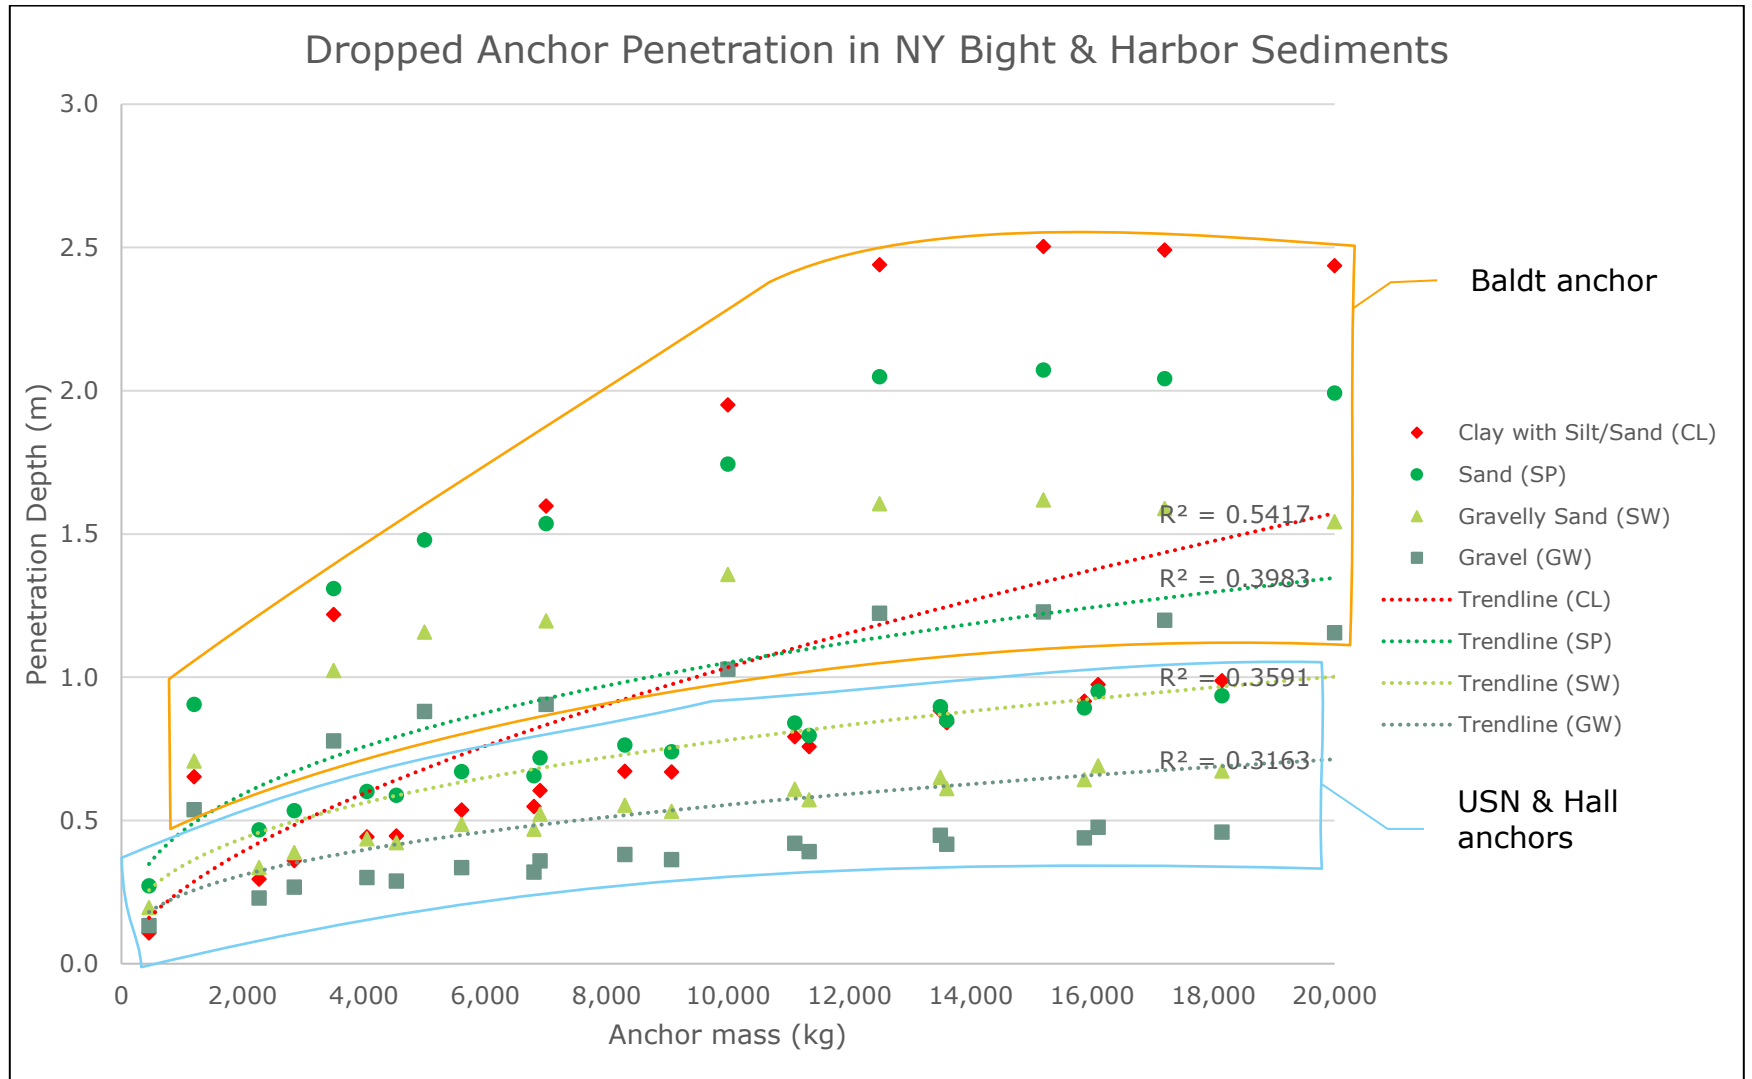
Figure 3-6 – Plot of anchor mass vs. dropped anchor penetration in clay with silt and sand (CL), sand (SP) gravelly sand (SW), and gravel (GW), calculated using the Ref. [47] method.

According to the procedures laid out in Section 3.3.1, the more compact Baldt anchor achieves the highest penetration depths, up to an estimated 2.5m (8.2 ft) in clay, 2.1m (6.9 ft) in sand, 1.6m (5.2 ft) in gravelly sand, and 1.2m (3.9 ft) in gravel for a 15,200 kg (33,510 lbm) anchor. The four largest Baldt anchors examined, ranging from 12,500 kg to 20,000 kg (27,558 lbm to 44,092 lbm), appear to level off at approximately the same penetration depths. The maximum penetration depth achieved by a 16,100 kg (35,494 lbm) Hall anchor, a slightly larger mass than the Baldt but larger bearing area, is estimated to penetrate only approximately 1.0m (3.3 ft) in clay and sand, 0.7m (2.3 ft) in gravelly sand, and 0.5m (1.6 ft) in gravel. The five largest USN/Hall anchors examined, ranging from 12,500 kg to 20,000 kg (27,558 lbm to 44,092 lbm), appear to level off at approximately that same penetration depth.

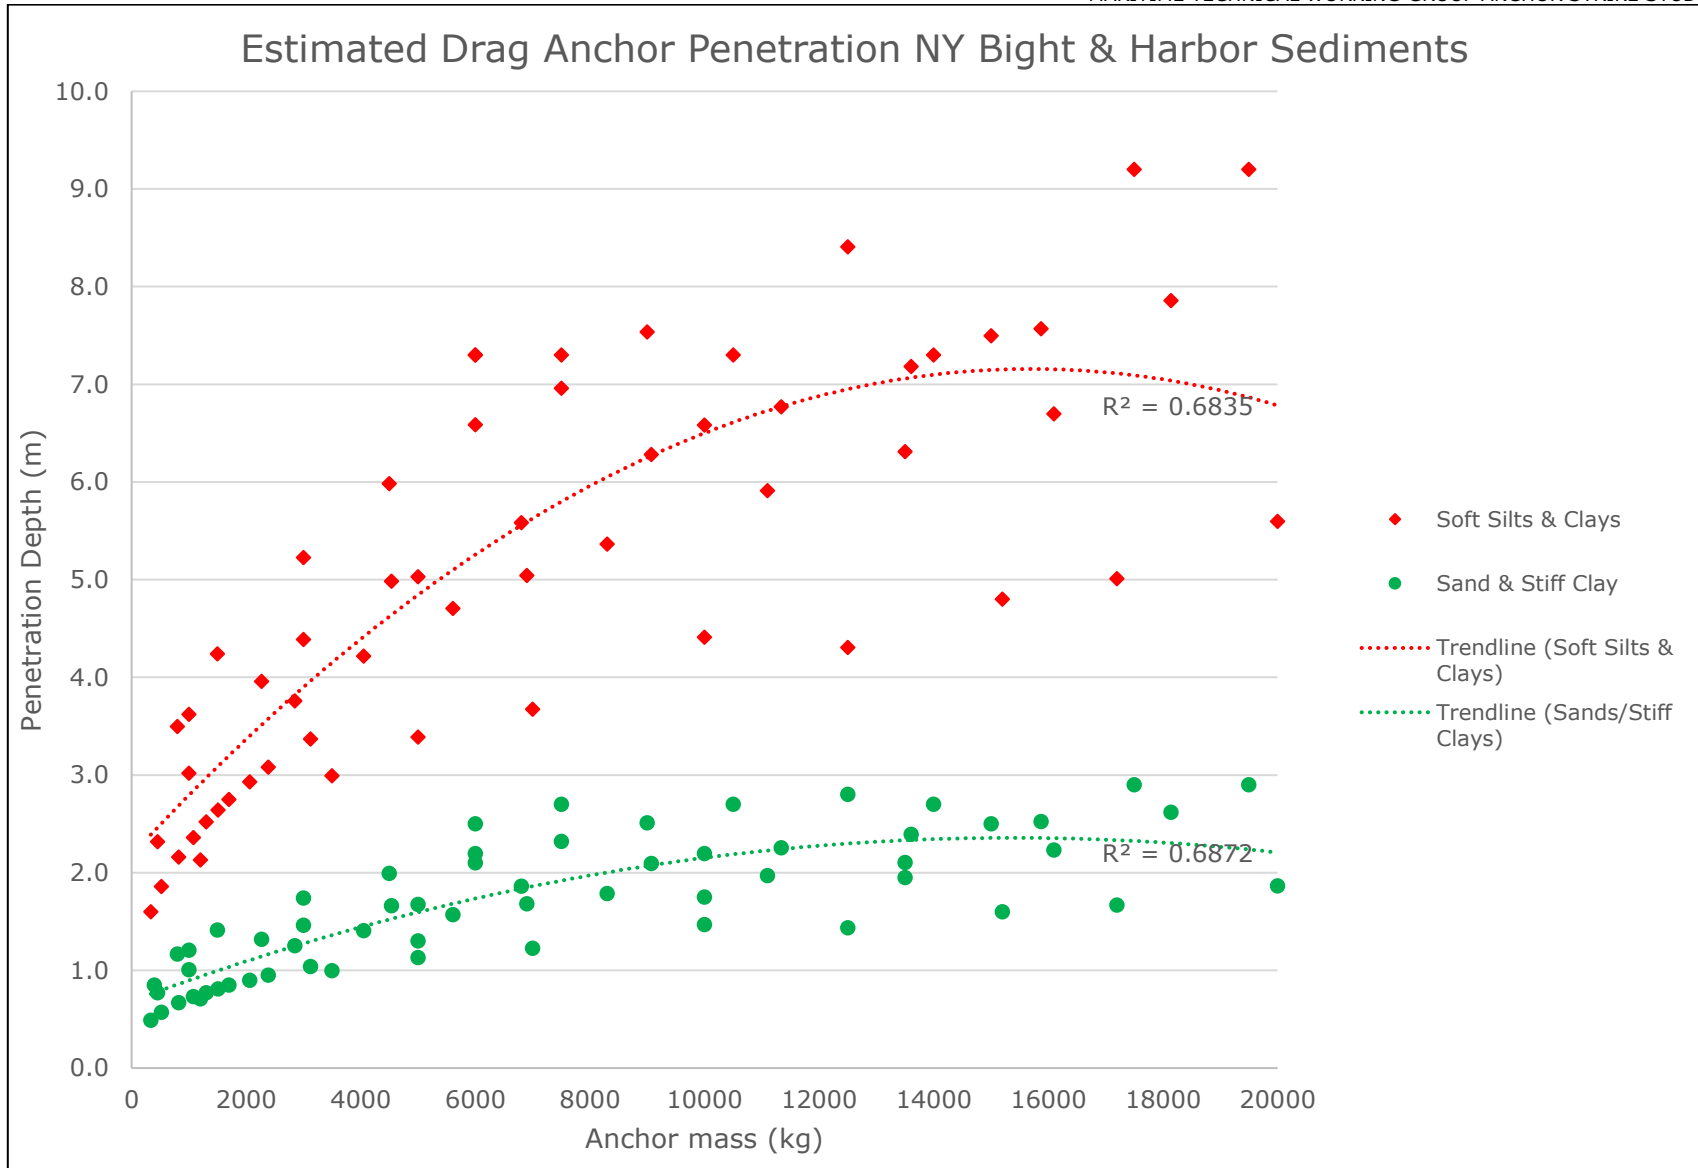
Figure 3-7 – Plot of drag anchor penetration in soft silts & clays and sands & stiff clays based on empirical data and relationships.

In sands and stiff clays, no anchor of a size expected in the study area exceeds 2.9m (9.5 ft) of drag penetration depth. In soft silts and clays, a maximum penetration depth of 9.2m (30.2 ft) could be achieved with a 17,500 kg (38,581 lbm) and 19,500 kg (42,990 lbm) anchor according to the Ref. [1] estimates, assuming the soft layer is that thick and not underlain by a harder layer. Using the Ref. [53] fluke length-to-penetration depth correlation, in soft silts and clays, a maximum penetration depth of 8.4m (27.6 ft) could be achieved with a 12,500 kg (27,558 lbm) anchor (2.8m [9.2 ft] long flukes).

Like in the dropped anchor scenario, there is a visible split between stockless anchor types. The compactness of Baldt anchor extends to its shorter flukes, which results in shallower drag anchor penetration. For example, the 15,200 kg (33,510 lbm) Baldt anchor is only expected to penetrate 4.8m (15.7 ft) into soft silt/clay and 1.6m (5.2 ft) into sand/stiff clay. A USN or Hall anchor of smaller mass, such as a 13,500 kg (29,762 lbm) Hall anchor could penetrate 6.3m (20.7 ft) and 2.1m (6.9 ft), respectively, into those sediments.
